ALASKA STATE TROOPERS, A DETACHMENT, F.M.O.I. PORT.
INVESTIGATED BY DFM's Jerry Gentile/Theresa A. Smith DATES INVESTIGATED June 9-10&17, 2000

TITLE OF CASE FIRE -Other Vehicle M/V Columbia State of Alaska Ferry

SUPPLEMENTAL REPORT Written by Deputy Fire Marshal (DFM) Gentile

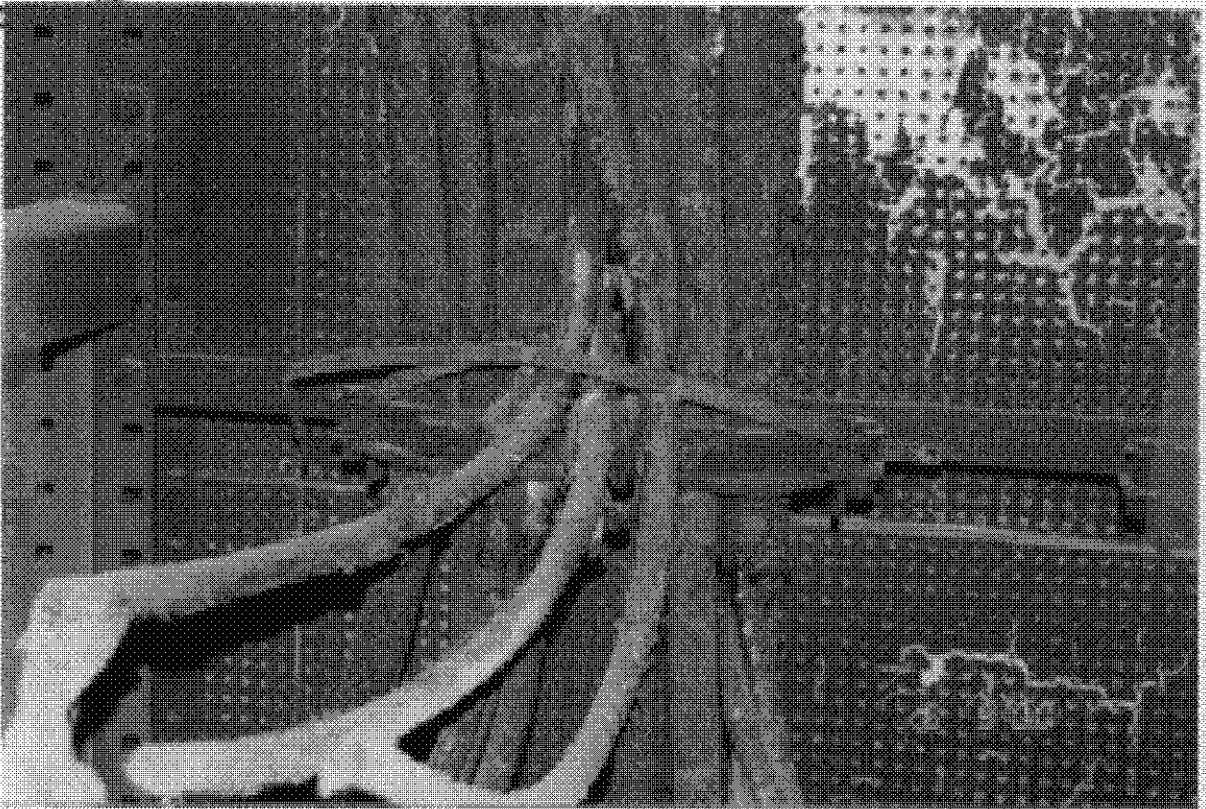
EXPOSURE 25 DEFECTS Banding w/o rubber insulator

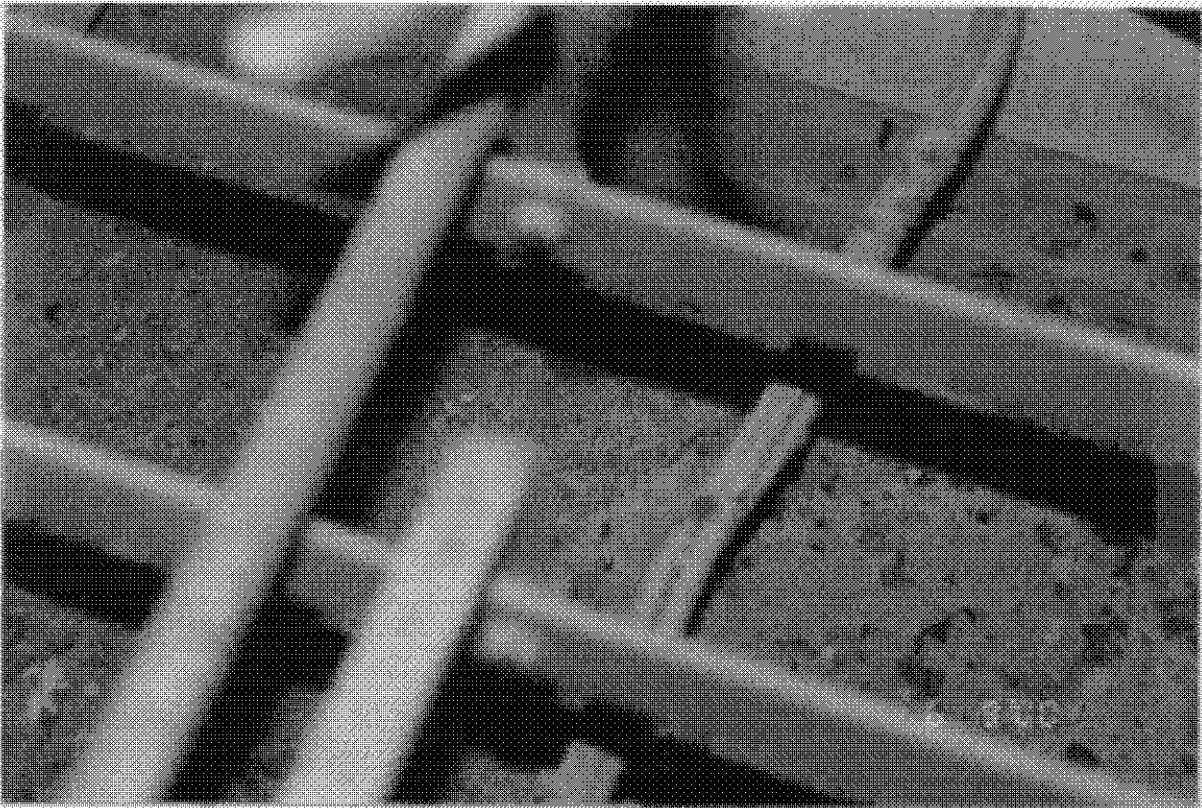
EXPOSURE 10A DEFECTS Banding under panel #1 on deck left base

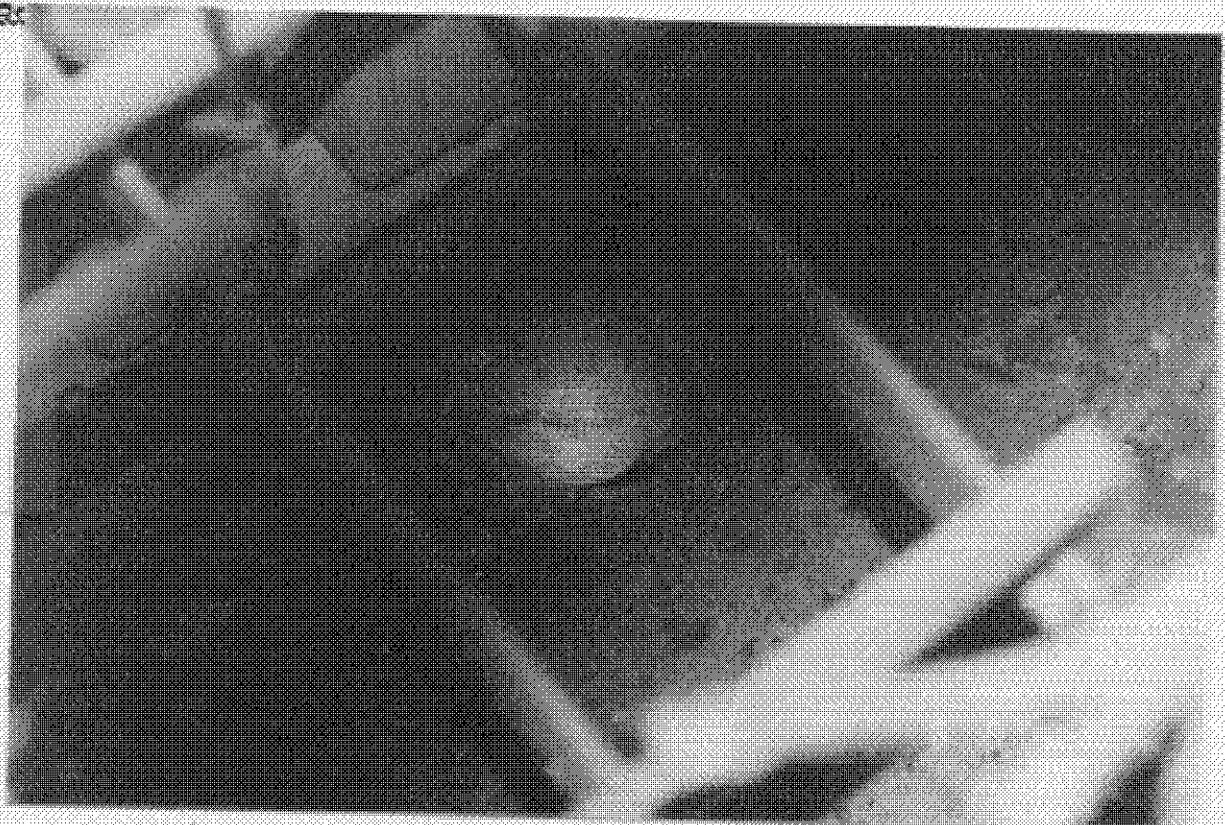
EXPOSURE 11A DEPICTS More Banding on last panel #1

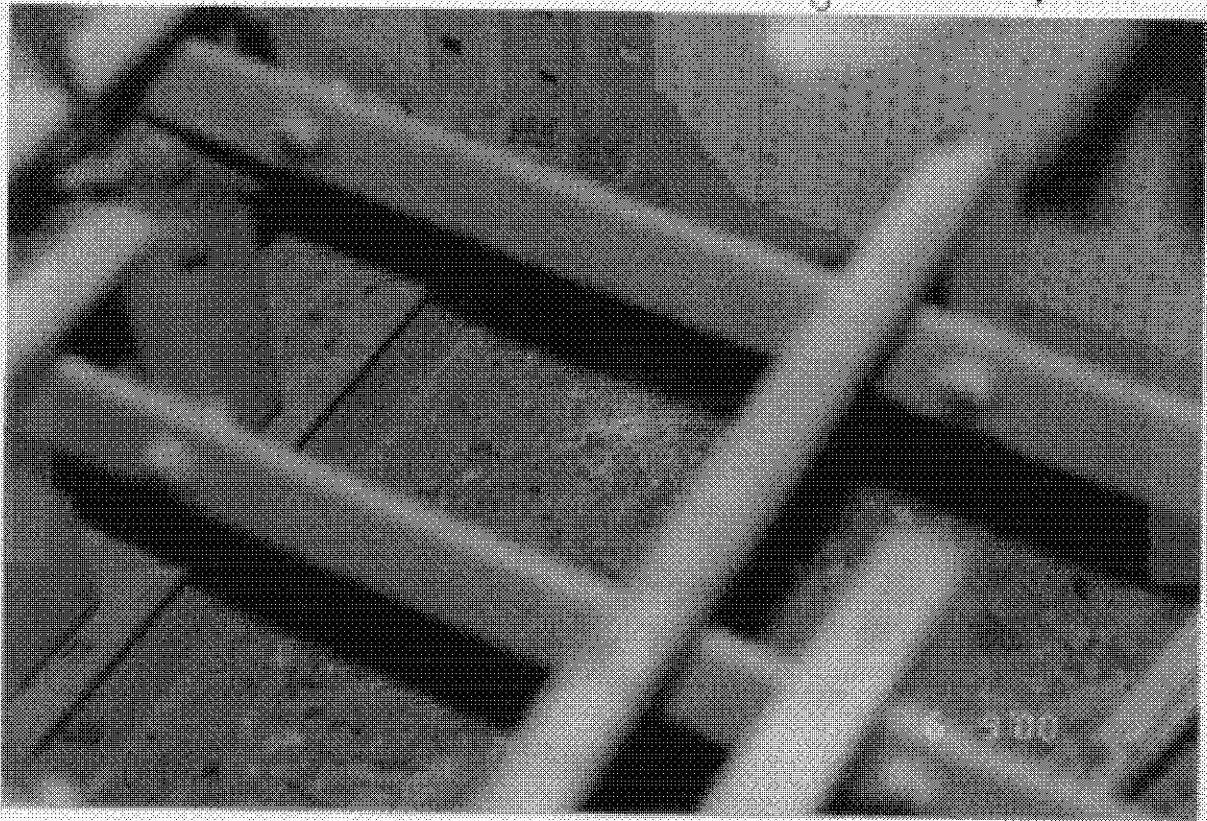
EXPOSURE 12A DEPICTS Banding Panel #1

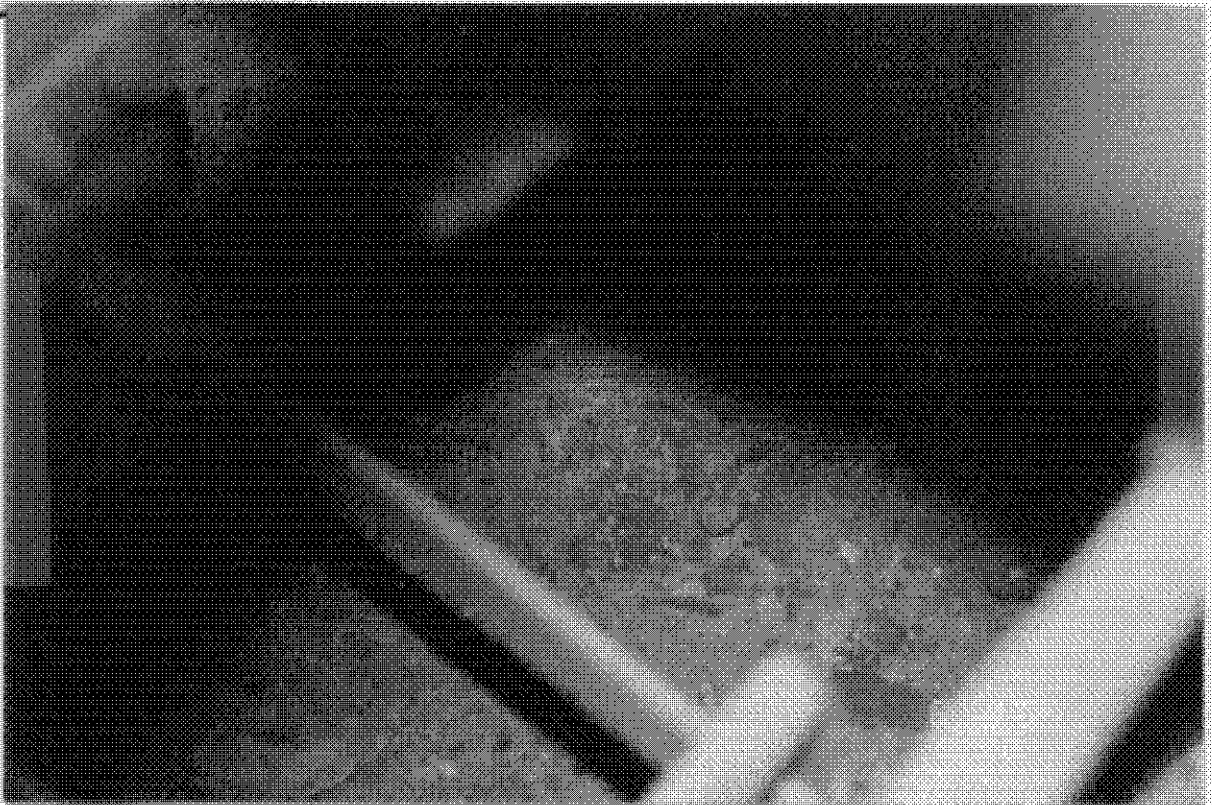
EXPOSURE 13A DEPICTS Banding Panel 7

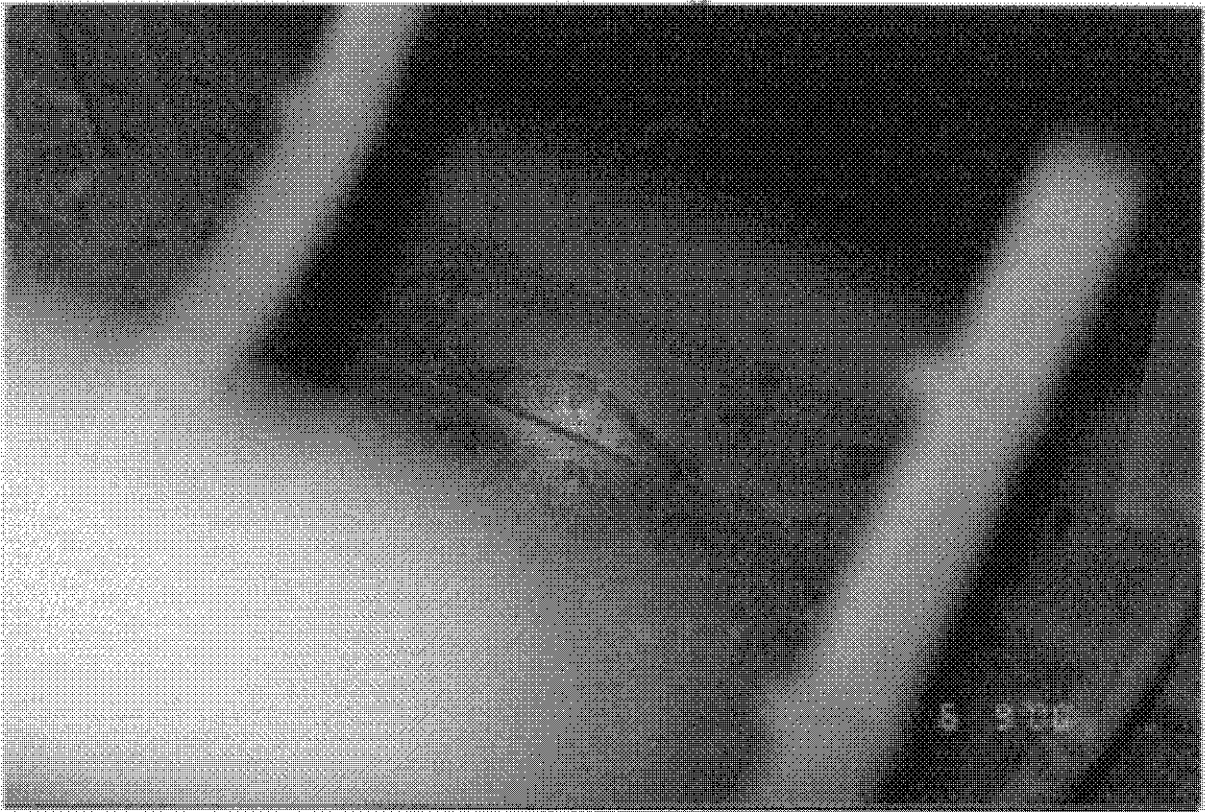
EXPOSURE 14A DEPICTS Banding Panel #1

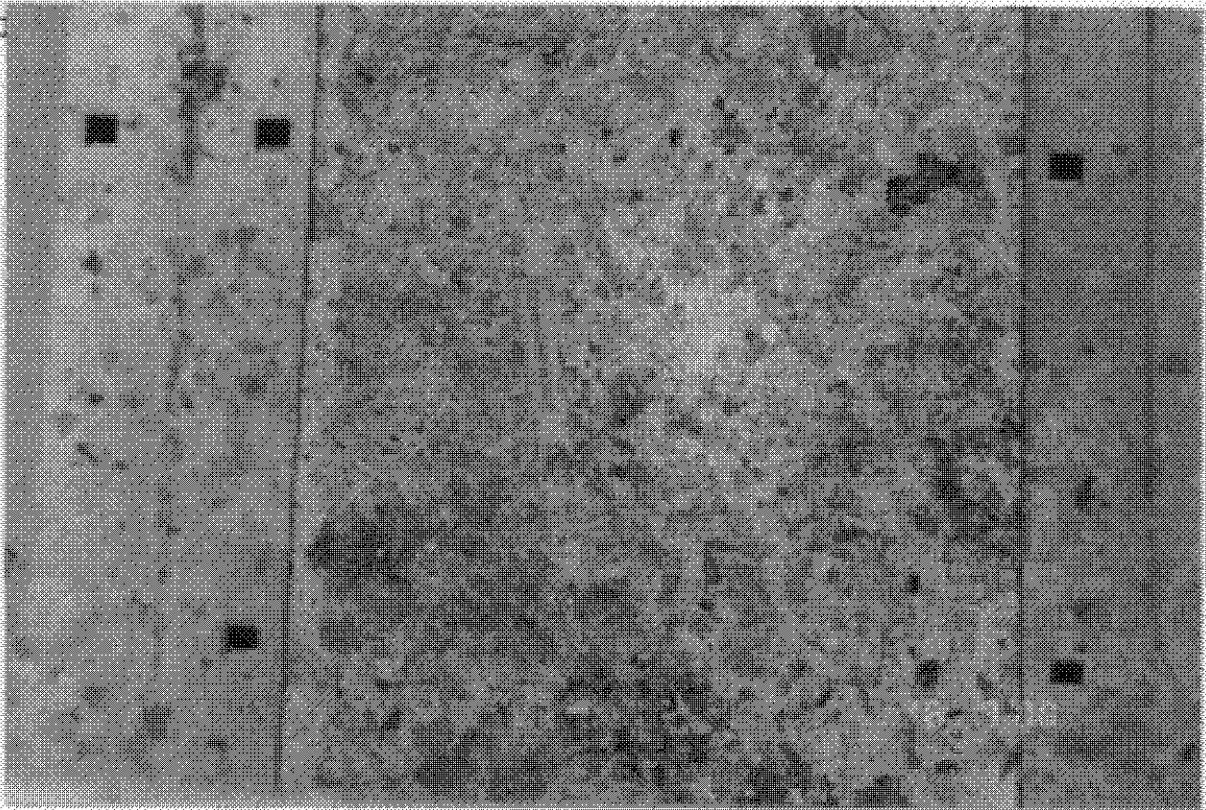
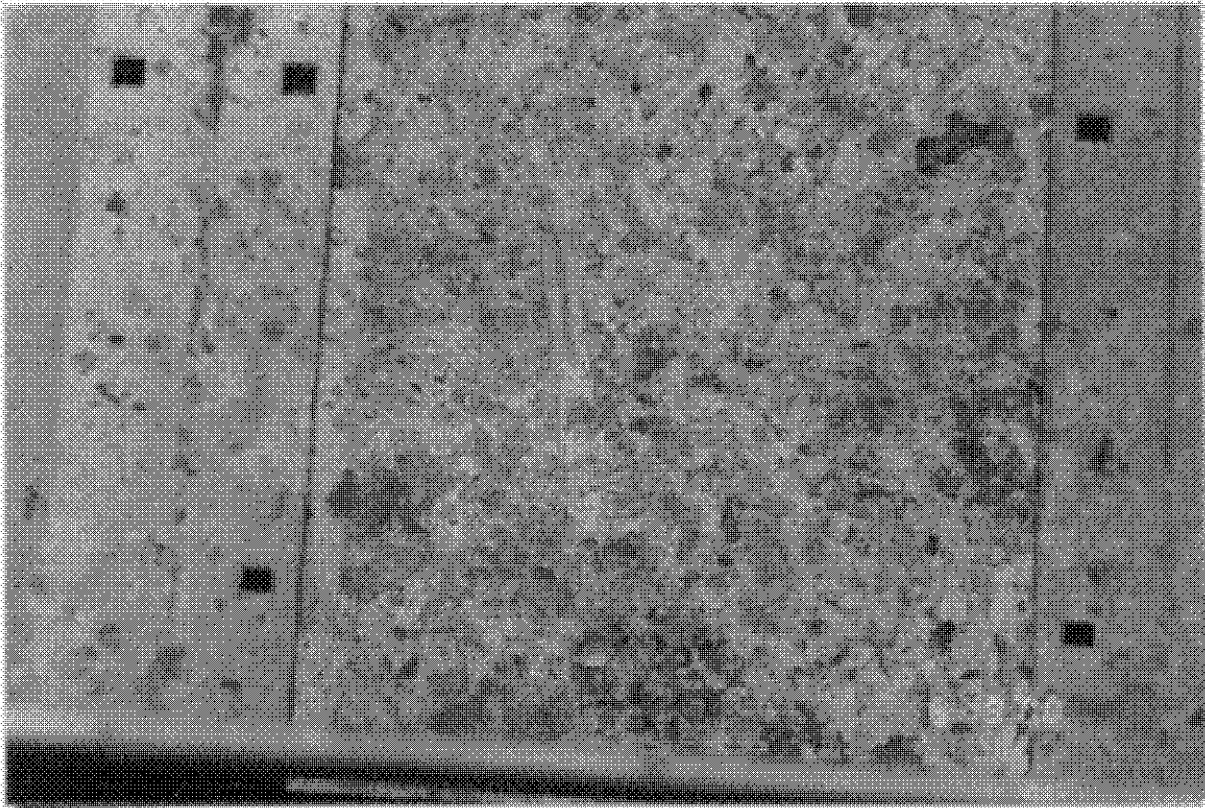
EXPOSURE 15A DEPICTS Paneling on wall between Panels 1 & 2

EXPOSURE 16A DEPICTS Same as 15A

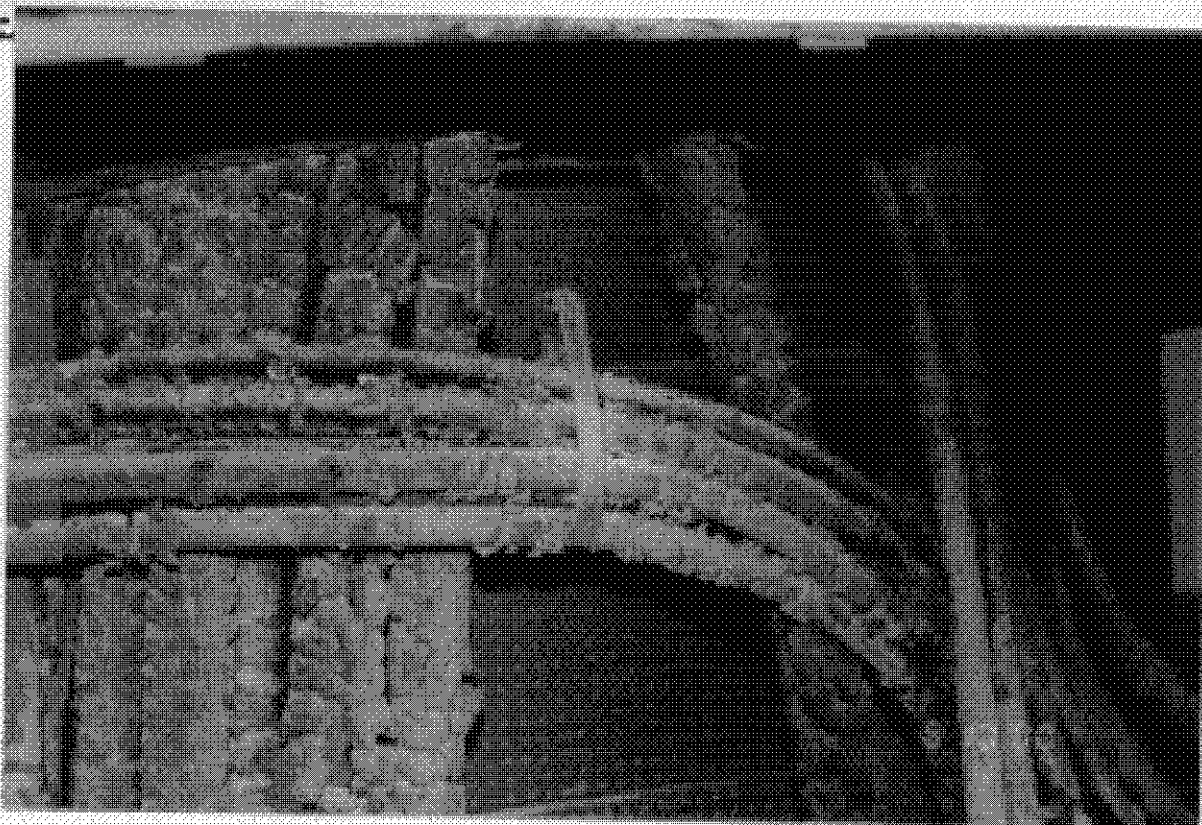
EXPOSURE 20A DEFECTS Banding on cables w/o insulator
